Queens Lake Dam
Dam Safety Inventory #199016

Dam Break Inundation Study

February 2021

STRUCTURAL EVALUATION OF THE QUEENS LAKE SPILLWAY

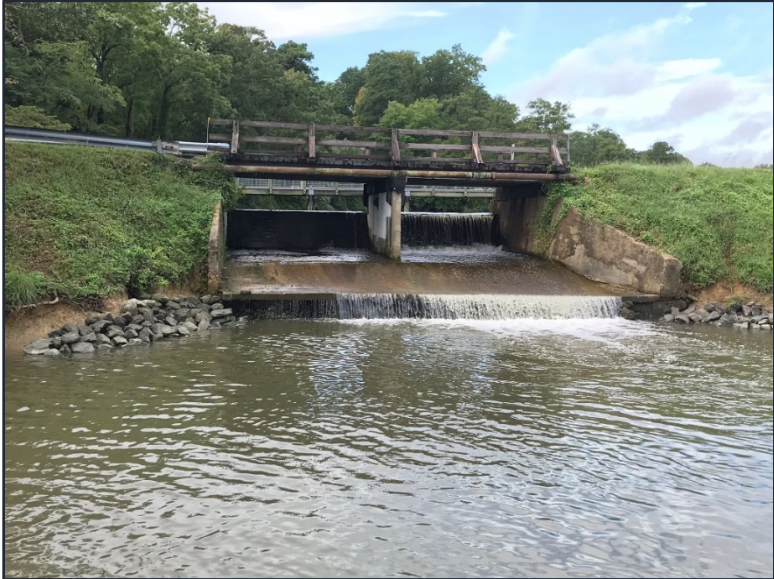
Picture 2.1 – Queens Lake Dam Spillway Outfall

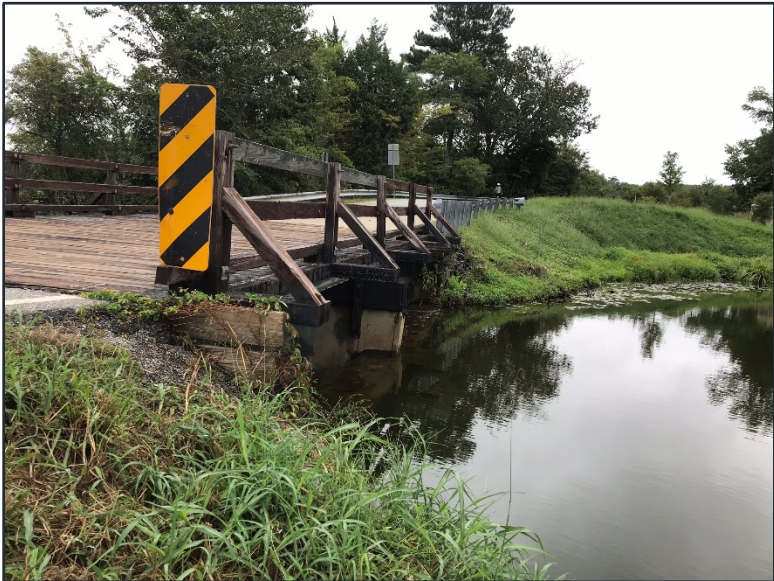
Picture 2.2 – Queens Lake Spillway Inflow

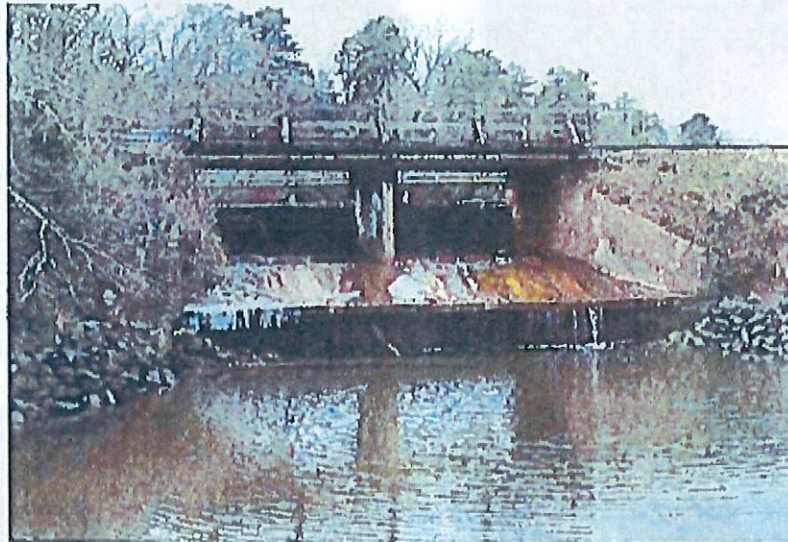
01.1: OVERALL PHOTO – SPILLWAY ON THE NORTH FACE

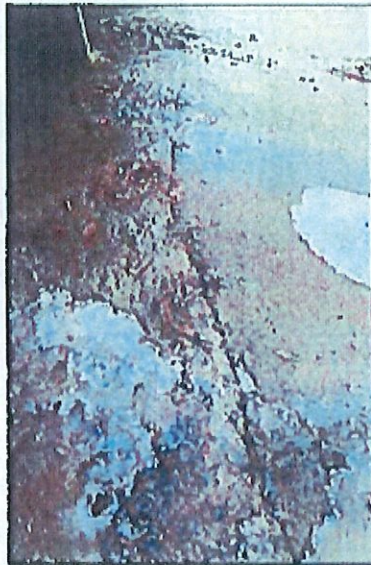
2. At the top of the slope on the outfall slab there is a crack that begins at the East abutment wall and runs approximately 3/4 of the distance across the slab (see photos 01.12, 01.13 and 01.14). The crack varies in width from almost 1/4 inch down to a hairline, then disappears. This crack could be patched, but we do not feel patching is necessary at the present time. We might watch the crack over a period of time to see if it is continuing to move.

01.12: CRACK ACROSS SPILLWAY

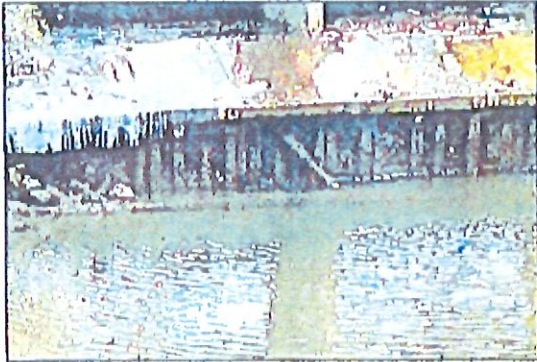
4. At the outfall of the spillway there is a vertical concrete bulkhead. From a distance it appears the face is spalled and rough. Up close it is obvious the rough surface is from barnacles that have attached themselves to the face of the wall below the water line. The face of the wall above the water line is clean and smooth. Timber planks that are visible on the face of the bulkhead appear to be form boards used when the wall was first poured. These boards do not appear to have a structural function.

01.17: CONCRETE WALL AT THE TOE OF THE SPILLWAY
