PRELIMINARY ENGINEERING REPORT
FOR
QUEENS LAKE DAM
YORK COUNTY, VIRGINIA
AMT PROJECT #20-0081.001

October 23, 2020

Preliminary Engineering Report for the Queens Lake Dam

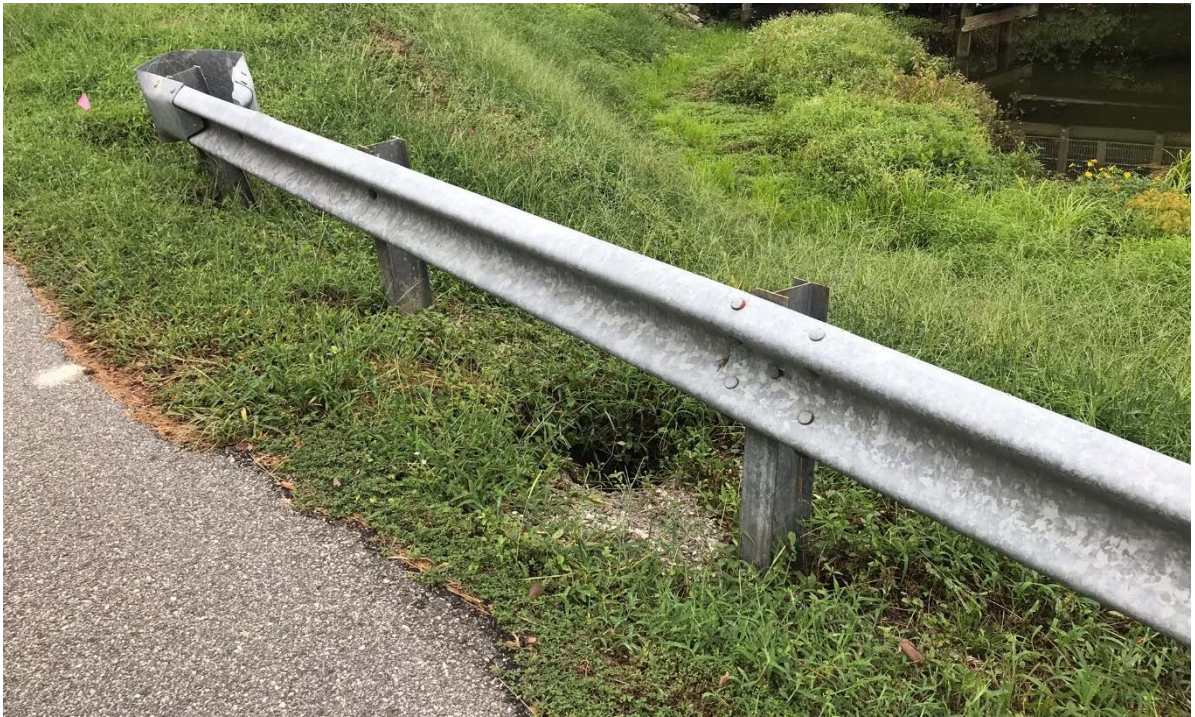
Photo 2 – Holes under the Guard Rail Posts (being addressed by VDOT)

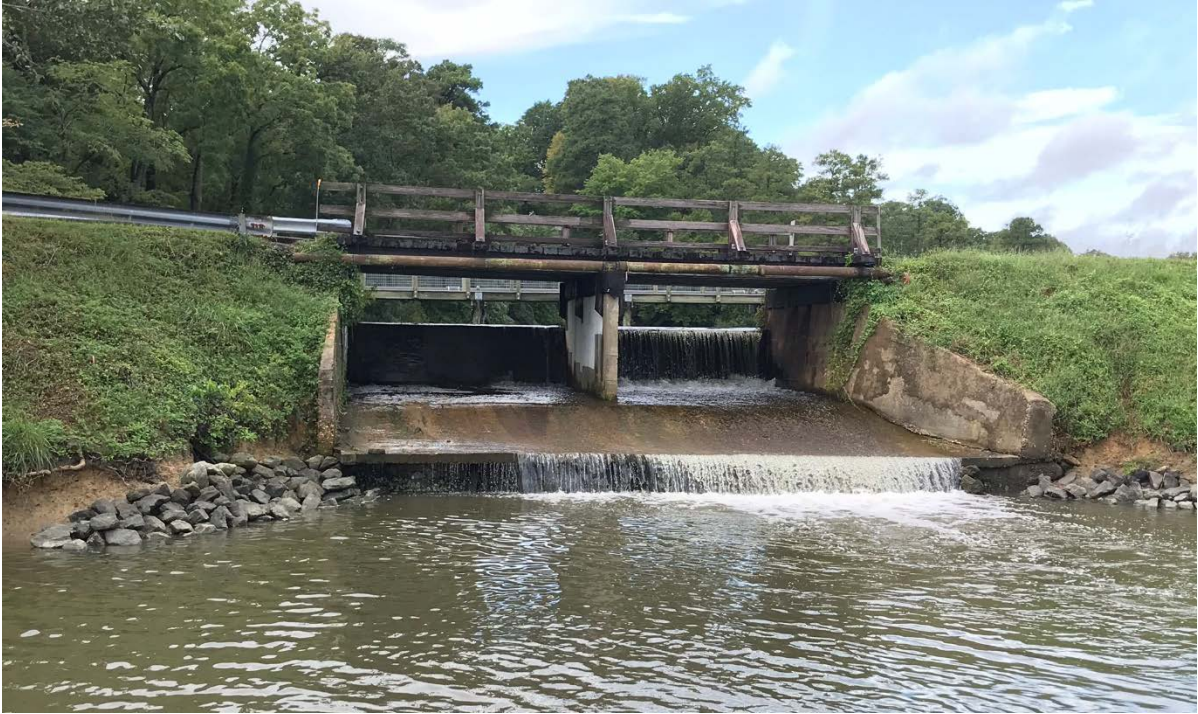
Photo 3 – Existing concrete spillway under the wooden bridge (bare slopes on both sides)

4. QLCA is already rehabilitating the concrete spillway in accordance with the structural evaluation by TAM Consultants (September 2018) that is included in the report appendices, but AMT additionally recommends that QLCA backfill scour holes that have formed on the downstream side of the concrete spillway and under the spillway apron, then armor the slopes on both sides of the concrete spillway with filter fabric and riprap.

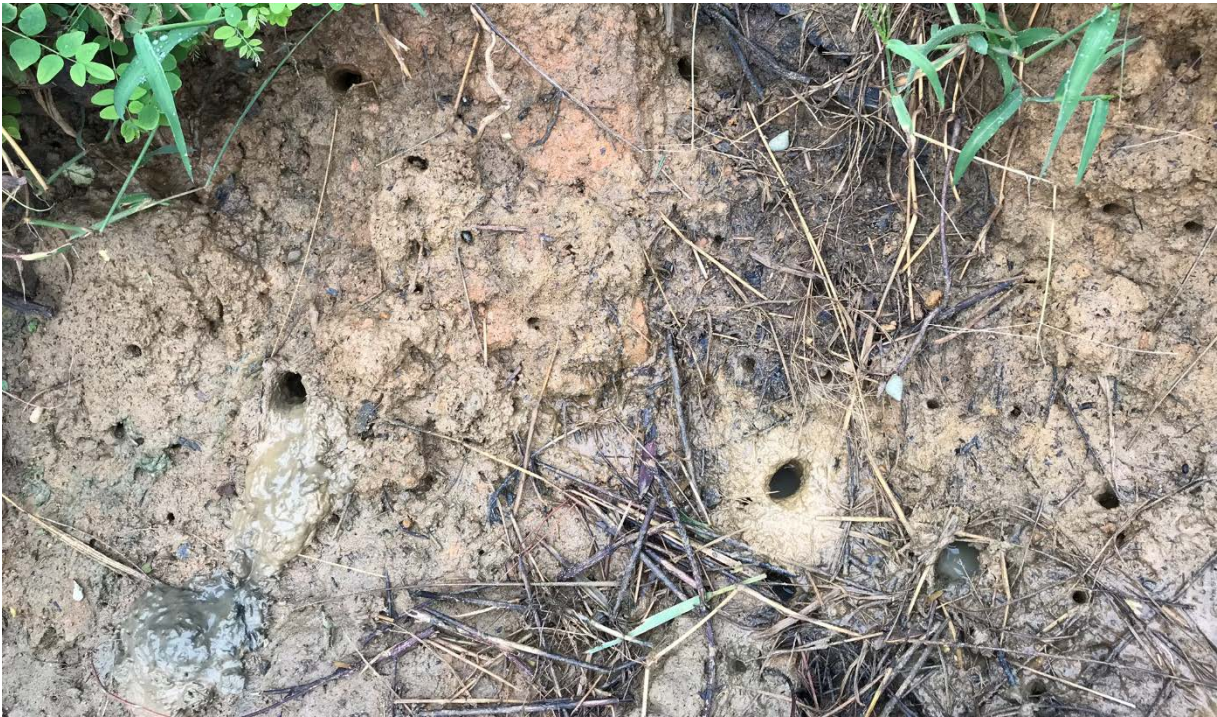
d. Any seepage or wet areas? Animal burrows were noted on bare earth slopes at the outlet end of the spillway on both sides.

Photo 4 – Small crabs and holes in the embankment near the concrete spillway

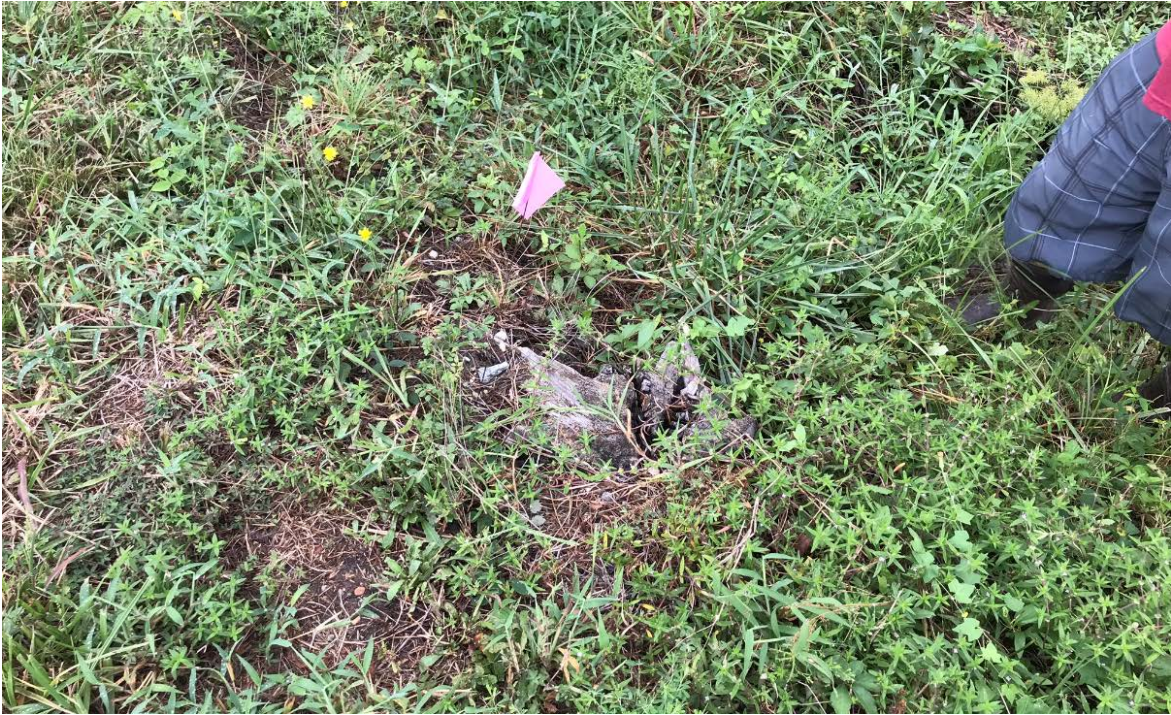
- a. Any alteration made to the embankment? Pink pin flags are now marking holes due to rodent burrows and/or rotting roots from trees that were removed after Hurricane Isabel (September 2003).
b. Erosion on embankment? Banks and sloughing were noted.
c. Settlement, misalignment or cracks in embankment? Holes were noted throughout the embankment. Also, there is some alligator cracking on the edges of VA Route 716 (East Queens Drive) which goes across the top of the dam.
d. Seepage? If so, seepage flow rate and location (describe any turbidity and observed color within the flow): None

Photo 6 – Buried Stump near downstream toe of dam (pink flags note holes forming)

2. Any remaining tree stumps or larger roots in the dam itself should be removed from the dam, and then the dam embankment can be rehabilitated in accordance with the geotechnical engineering recommendations from ECS Mid-Atlantic (see report appendices) in this report.

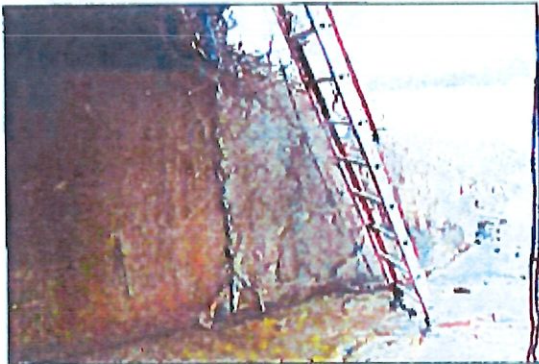
01.10: THERE IS A COLD JOINT BETWEEN THE WINGWALL AND THE ABUTMENT, AND ALSO AT THE BASE OF THE WINGWALL

- c. Repair all damaged concrete, fill cracks, and replace joint materials.
2. Based on previous geotechnical investigations and overly steep side slopes, the factor of safety for slope stability is a major concern for this dam. This report includes a geotechnical investigation of slope stability, and recommendations to achieve a 1.3 factor of safety on the dam embankment.

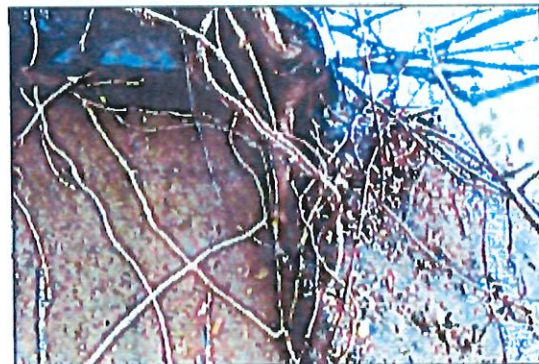
01.11: LARGE ROOTS ARE FORCING THE COLD JOINT TO SEPARATE

- a. Remove tree roots coming through cracks in the concrete structure or underneath it.
 - b. Clean barnacles and remove loose concrete or other deleterious materials from the exposed surfaces.

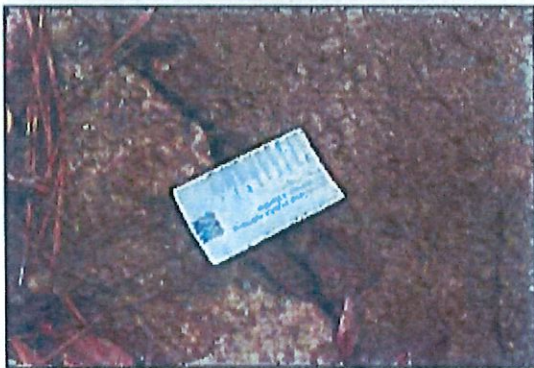
01.13: SPILLWAY CRACK VARIES FROM ABOUT 1/4" TO HAIRLINE

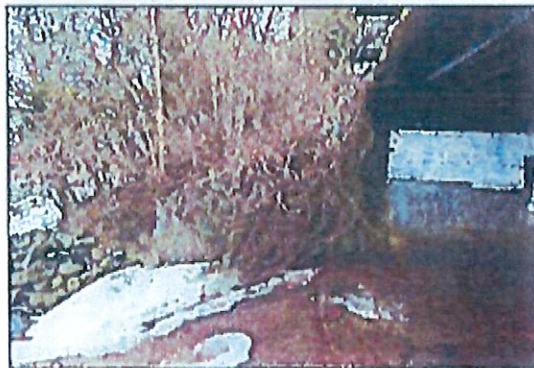
01.14: SPILLWAY CRACK LOOKING TOWARDS THE EAST ABUTMENT

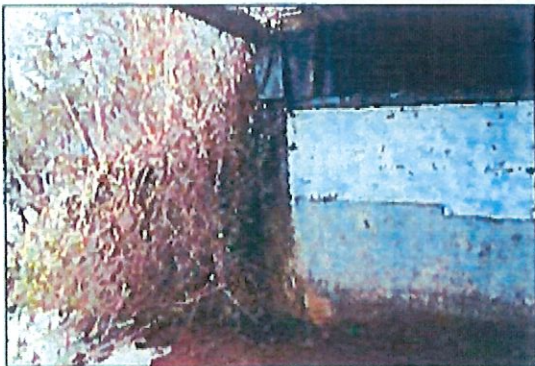
01.15: CRACK AND SPALL IN EAST ABUTMENT AT WING WALL

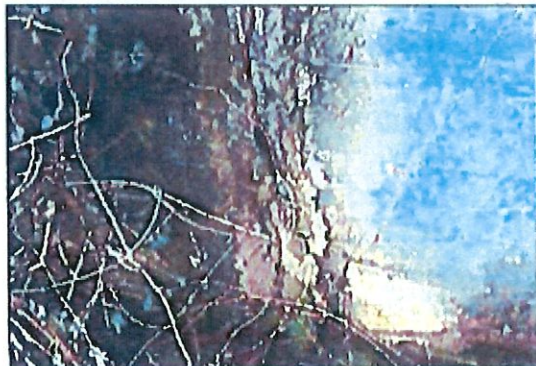
01.16: CRACK AND SPALL IN THE EAST ABUTMENT AT WING WALL

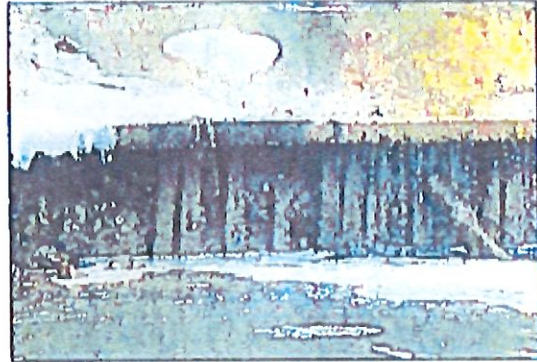
01.18: EXPOSED TIMBERS APPEAR TO BE PART OF FORMING FOR TOE

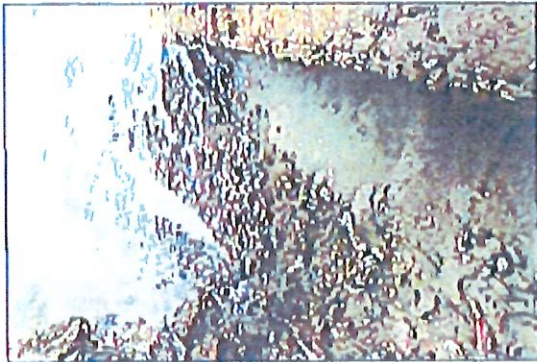
01.19: CONCRETE BELOW THE WATER LINE IS COVERED WITH BARNACLES
