Queens Lake Dam
Dam Safety Inventory #199016

Dam Break Inundation Study

February 2021

STRUCTURAL EVALUATION OF THE QUEENS LAKE SPILLWAY

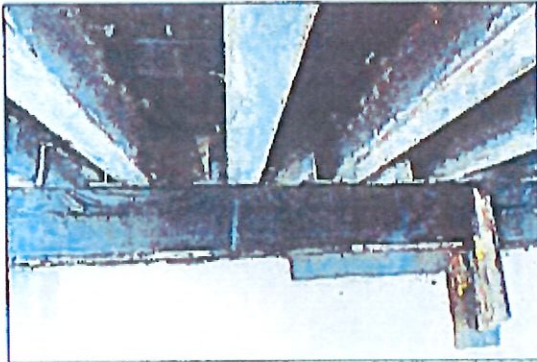
01.8: HEAVY TIMBERS CAP THE CONCRETE ABUTMENTS TO SUPPORT BRIDGE STRUCTURE

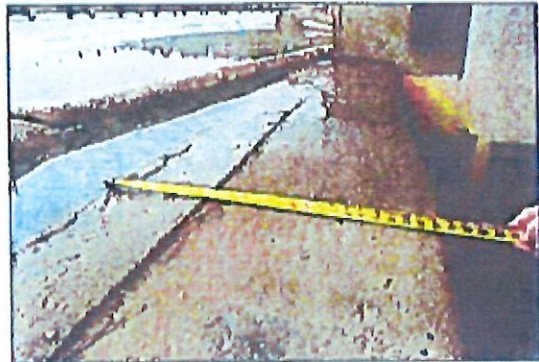
01.9: THE CONCRETE STRUCTURE APPEARS TO HAVE BEEN CONSTRUCTED IN VARIOUS SECTIONS

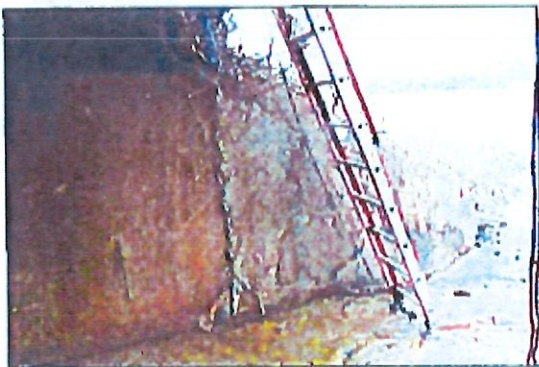
01.10: THERE IS A COLD JOINT BETWEEN THE WINGWALL AND THE ABUTMENT, AND ALSO AT THE BASE OF THE WINGWALL

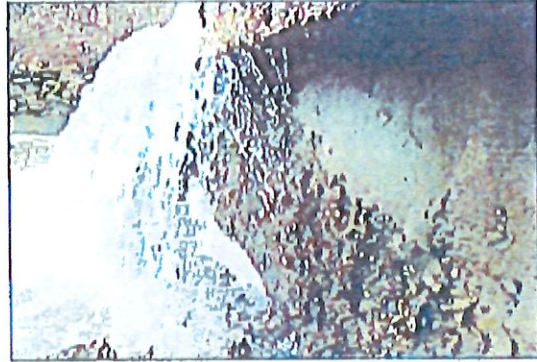
4. At the outfall of the spillway there is a vertical concrete bulkhead. From a distance it appears the face is spalled and rough. Up close it is obvious the rough surface is from barnacles that have attached themselves to the face of the wall below the water line. The face of the wall above the water line is clean and smooth. Timber planks that are visible on the face of the bulkhead appear to be form boards used when the wall was first poured. These boards do not appear to have a structural function.

01.20: ABOVE THE WATER LINE THE CONCRETE IS CLEAN AND SMOOTH
