Queens Lake Dam
Dam Safety Inventory #199016

Dam Break Inundation Study

February 2021

STRUCTURAL EVALUATION OF THE QUEENS LAKE SPILLWAY

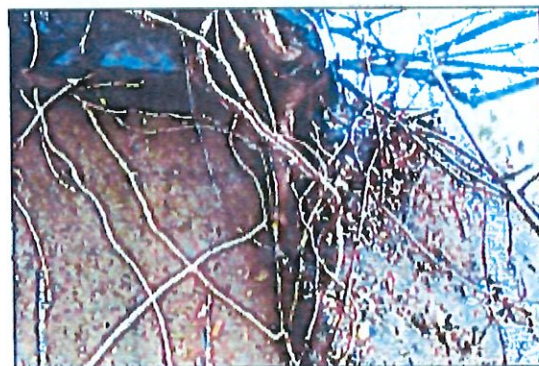
01.11: LARGE ROOTS ARE FORCING THE COLD JOINT TO SEPARATE
